ALEXANDRIA

KOM EL-DIKKA EXCAVATIONS 1995-1996 Grzegorz Majcherek

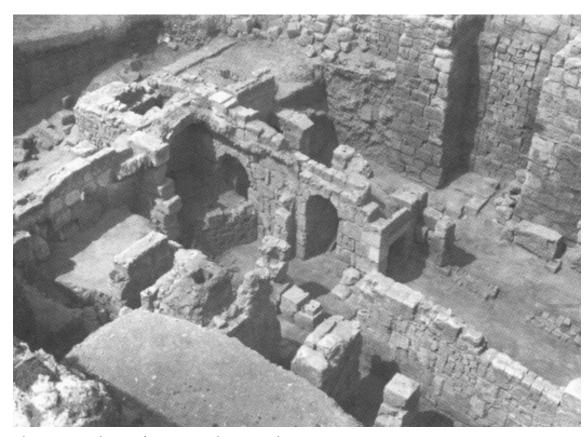
Phot. 1. General view of House FA. Photo W. Jerke.

This season our efforts focused on the exploration of the eastern wing of House FA, adjoining the pseudo-peristyled courtyard. We were able to excavate three more rooms bringing the total of the uncovered surface of the house to some 250 m². Thus, almost the entire area of the house available for excavations was explored (Phot. 1). Two major phases of occupation were again recognized in this fragment of the house, both reflecting subsequent changes in layout and function of the building.

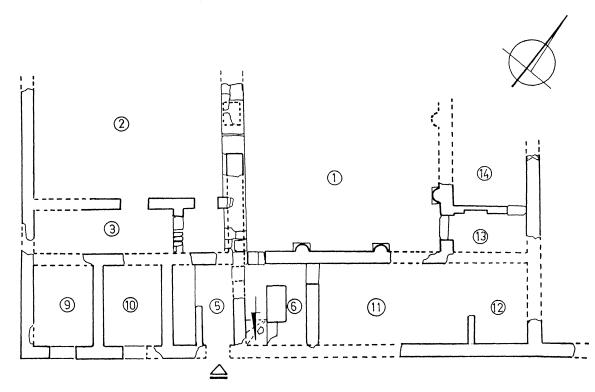
Fig. 1. House FA, original stage. Drawing G. Majcherek.

The exploration of room no. 6 accommodating the staircase was also completed (Fig. 1). In its southern part adjoining the façade, remnants of steps were uncovered. Contrary to the previous suggestion, the position of the steps excludes the possibility of the main entrance being located here. The entrance, therefore, must have been in the neighboring locus no. 5, serving at the same time as a vestibule giving access to the courtyard.

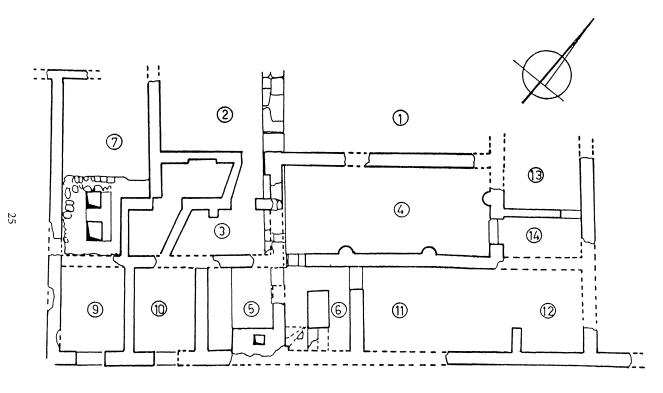
Fig. 2. House FA, second stage. Drawing G. Majcherek.

Following rather extensive damage, the building was rebuilt and its plan substantially altered (Fig. 2). Large sections of the walls, especially in the facade, were either re-structured or entirely rebuilt in new material. In some cases, partition walls were introduced; one such wall was built across the courtyard, dividing the building into two separate units. The exact purpose of this important modification is unknown. It would seem that the building lost its residential character at this time and began serving storage purposes. The later phase is well attested by occupation levels cleared in all three rooms, set usually some 0.70-0.80 m above the original floors. Finds trapped between these two floor layers should be ascribed to the later part of the 3rd century AD. Among the objects of special interest found on the floor was a fragmentarily preserved marble slab bearing a Greek inscription referring to the cult of Tyche, dated to the 2nd-3rd century AD (inv. no. 4399).
