SITE AND EXCAVATIONS

SAVING THE WALL PAINTINGS

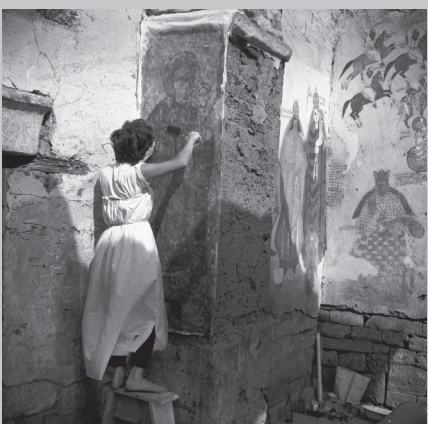
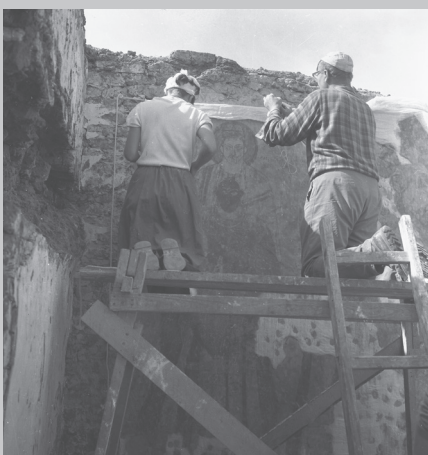
Restorers at work in Faras; transport of the packed paintings up the Nile to Wadi Halfa, 1964

whitewash and paint remained intact. The heavy fragment of painted plaster hung suspended vertically on the ropes attached to the fiberboard screen until, overcoming the inertia of the ropes, it dropped suddenly a few to a few dozen centimetres. The next step was to move the piece of plaster slowly away from the wall, so that the painted surface fell face down onto the panel and was placed horizontally. In this position the backs of the murals were cleaned of excess plaster using metal files, the main objective being to reduce the weight of individual pieces and reduce the deleterious effect of migrating salts contained in the mortar. The paintings were then moved to wooden boards and stored in a makeshift storeroom in one of the interiors of the cathedral.

In April 1964, the packed paintings embarked on a long journey away from Faras. Some were to go to Khartoum, others even further – to Warsaw as part of the archaeological license agreement. The region around Faras had already been evacuated, so the expedition was forced to make the wooden crates by themselves. Each crate contained two paintings, matched by size and wrapped with specially made cotton duvets. The crates were moved on river boats to Wadi Halfa and from there, supervised by Józef Gazy and Stefan Jakobielski, they were taken by rail to Khartoum and Port Sudan. Scaled wooden models of the crates helped to prepare the logistics of the sea journey to Poland.
